SPFA-139

Repair of Spray Polyurethane Roof Systems Due to Hail and Wind-Driven Damage

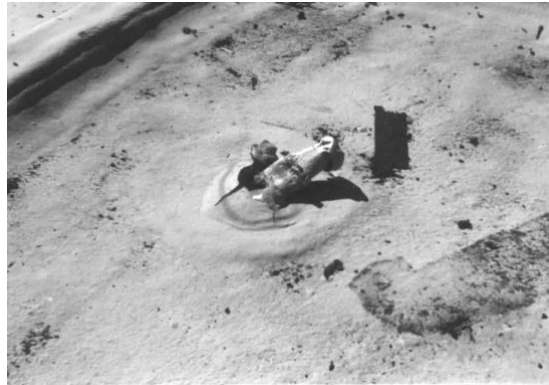
(1) Mechanical damage due to wind driven missiles

During high-wind events, a wide variety of objects can potentially impact a roof and produce damage to the protective coating and SPF. This damage may be isolated to small areas of the roof or cover large areas. Substrate and structural damage may or may not have occurred and should be thoroughly investigated. The type of repairs required will depend on the size and severity of the damage, and should be consistent with SPFA Guideline SPFA-122, "The Renewal of Spray Polyurethane Foam and Coating Roof Systems."

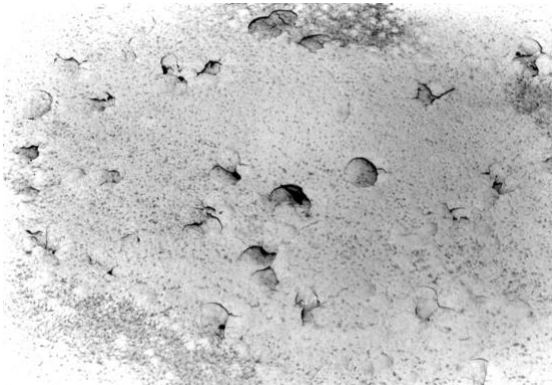
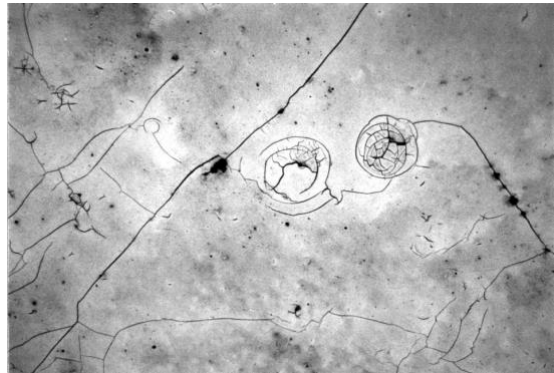
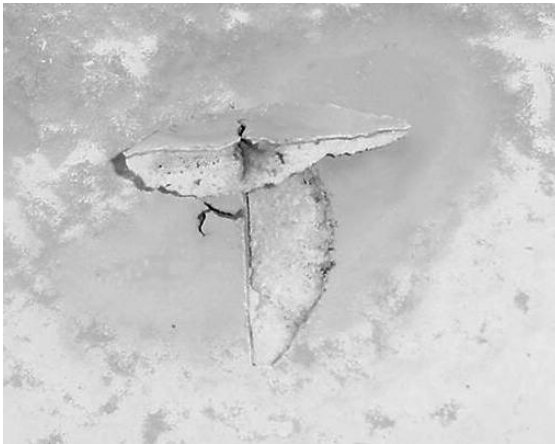
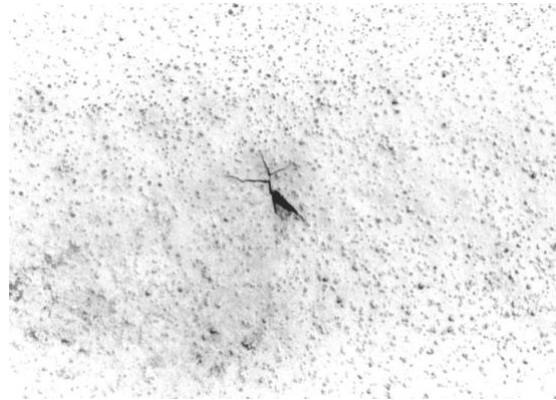
(2) Hail

Hail can damage both the surface coating and the underlying foam in an SPF roof system.

Coating damage can appear as gouges, cracks, and punctures. Hail-induced coating cracks often form patterns shaped like “crow’s feet” or semicircles.

Depending on the hailstone size, shape, and hardness, the underlying foam may be dented, cracked, or gouged. Depressions in SPF dented by hailstones may be 1/8 inch to 3/4 inch deep. Hail damage can be isolated to small areas or can cover the entire roof surface.

The repair technique is determined from the severity (size and depth of damage) and extent (number of hail hits per unit area) of the hail damage. For example, fifteen 3-inch diameter hail dents on a 1,000 square foot roof may be easier to repair than hundreds of 3/4-inch-diameter dents.
